CONCRETE CANVAS®

ROOT RESISTANCE TESTING

GEOSYNTHETICS TEST REPORT

REPORT REFERENCE: BS-J861/b

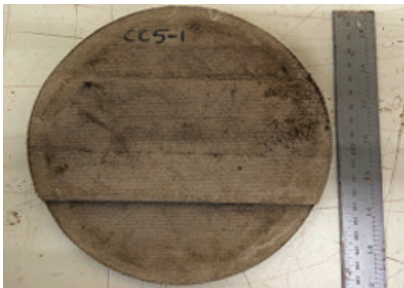
Figure 1: Upper surface after test. No root penetration

Both the exposed (top) side and underside of the material was examined and in all cases there was no evidence of root penetration through either the material or the joint.

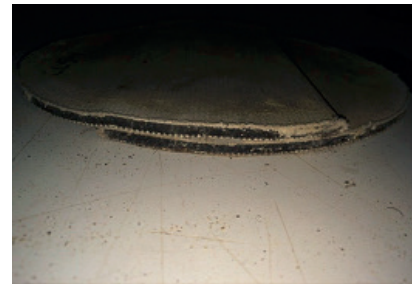
Figure 2: Joint after test. No root penetration

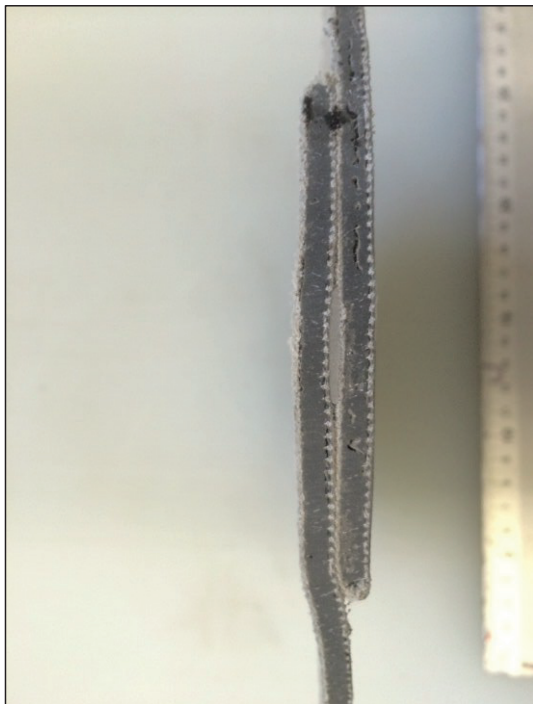
Figure 1. Typical overlap section (joint) prior to exposure

Three samples of CC5 overlap sections (Figure 1) were placed in soil into which seeds of lupin were sown. The seeds were grown during the period 23/05/2014 - 01/08/2014. At the end of the test the samples were examined to see whether the barrier/joints had been penetrated by the roots of the young plants.

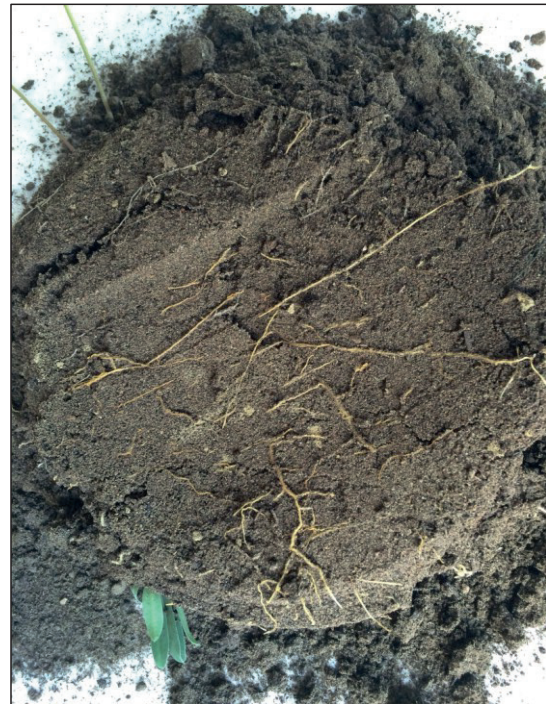
Figure 2. Typical root system at the CC5 interface after testing

Both the exposed (top) side of the barrier and the underside of the barrier have been inspected, and there is no evidence of penetration (either through the material or the joint) from the roots on any of the samples tested. Photographs have been taken to show both surfaces and joints of the test samples.

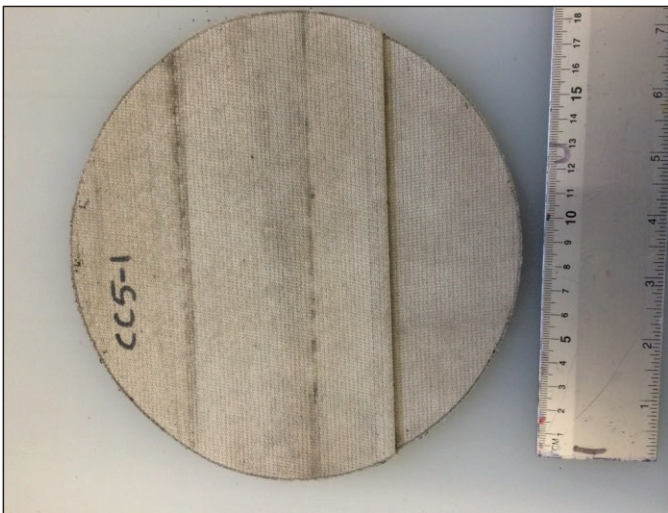
Figure 3. CC5-1 Before the test (upper surface)

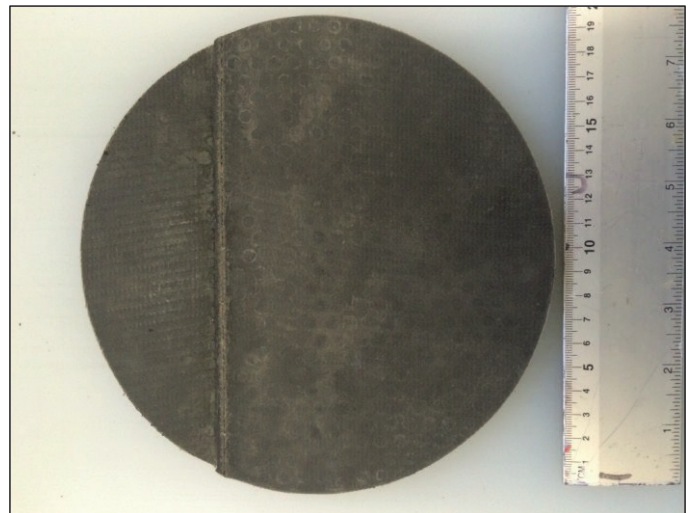
Figure 4. CC5-1 Before the test (lower surface)

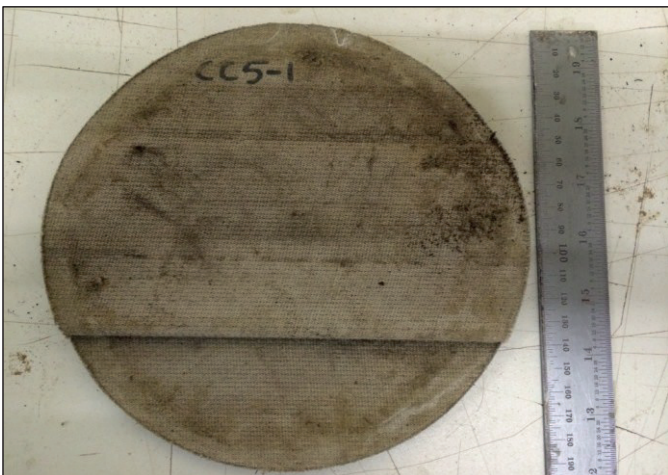
Figure 5. CC5-1 After the test (upper surface), no root penetration

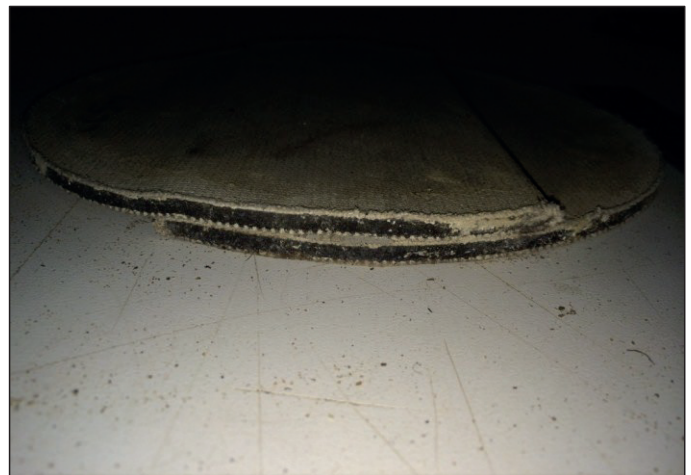
Figure 6. CC5-1 joint after the test, no root penetration

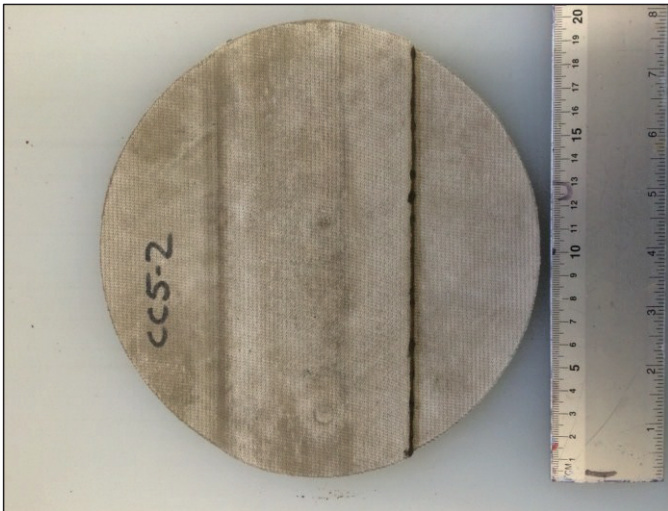
Figure 7. CC5-2 Before the test (upper surface)

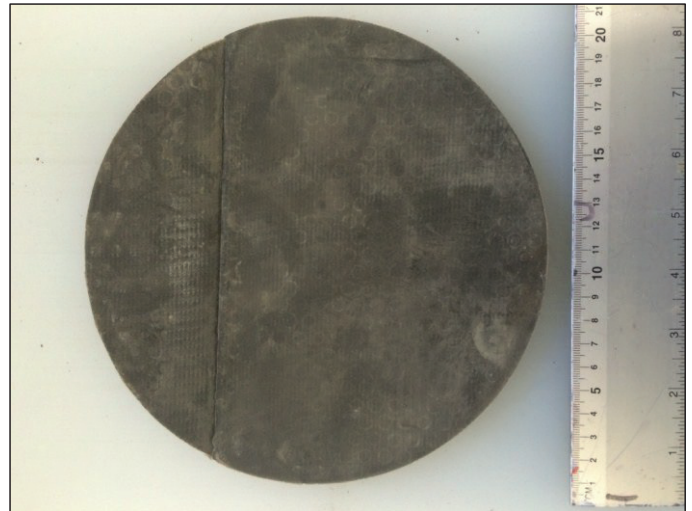
Figure 8. CC5-2 Before the test (lower surface)

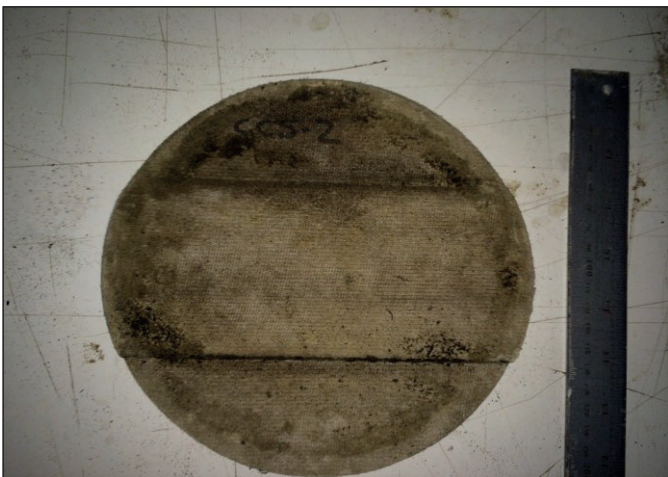
Figure 9. CC5-2 After the test (upper surface), no root penetration

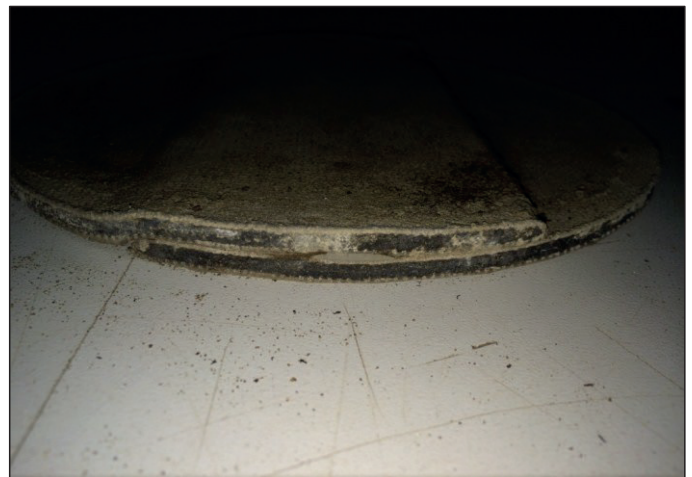
Figure 10. CC5-2 joint after the test, no root penetration

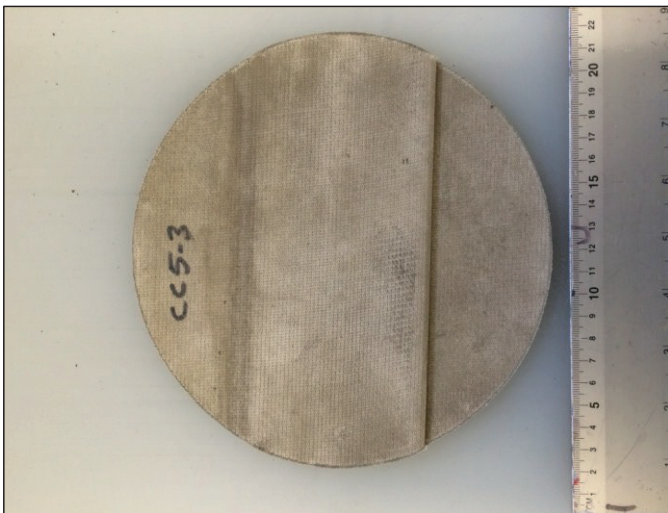
Figure 11. CC5-3 Before the test (upper surface)

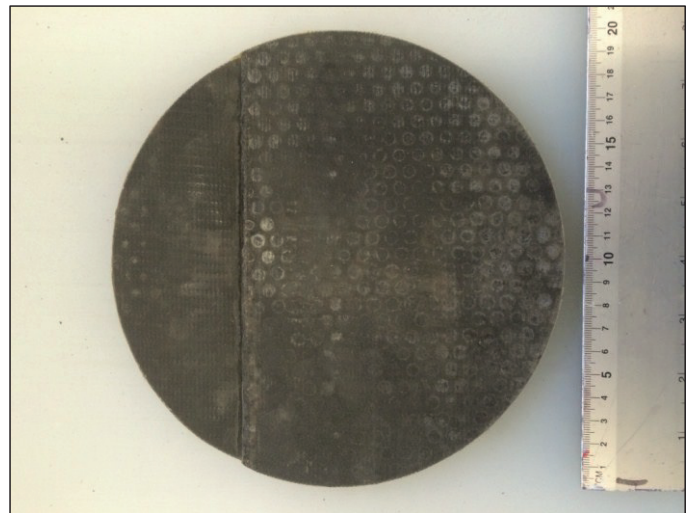
Figure 12. CC5-3 Before the test (lower surface)

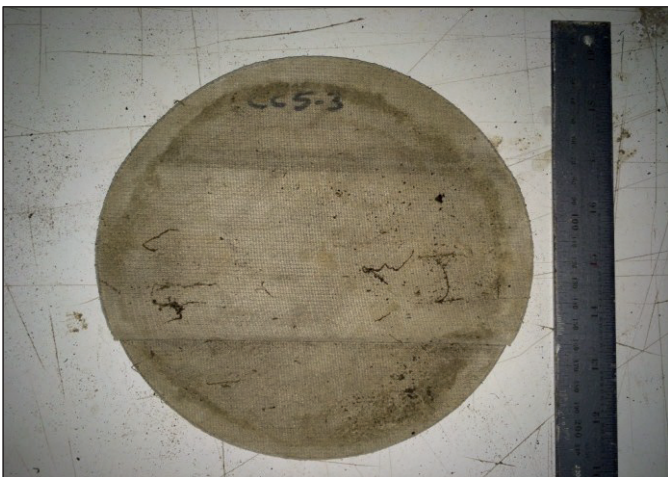
Figure 13. CC5-3 After the test (upper surface), no root penetration

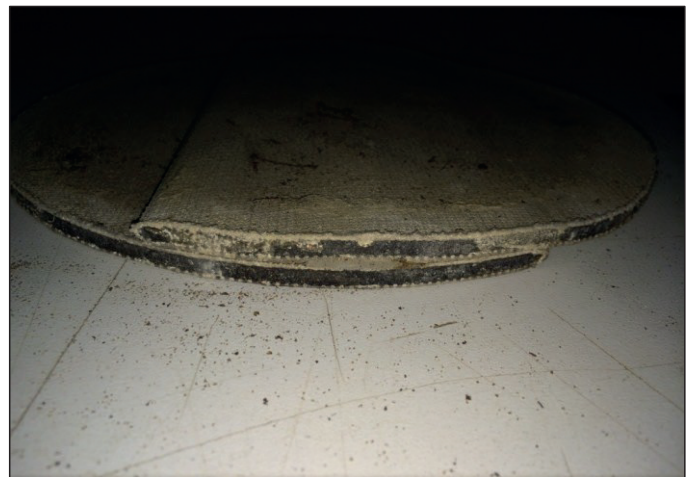
Figure 14. CC5-3 joint after the test, no root penetration
